# **ROAD TRAFFIC CRASHES ON THE KONONGO- KUMASI HIGHWAY - TWO YEARS AFTER RECONSTRUCTION**

**A thesis Submitted to the Department of Civil Engineering, Kwame Nkrumah  
University of Science and Technology in Partial Fulfillment of the Requirement for  
the Award of the Degree  
of**

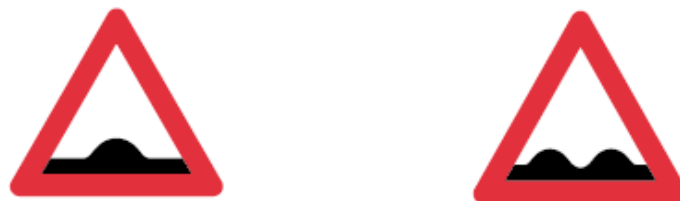
**Figure 2.9 Pre-warning signs, speed humps (LHS), rumble strips/jiggle bars (RHS)**

The purpose of pre-warnings is to warn drivers about a hazard, settlement or speed limit ahead and ensure that they are aware of the need to slow down.

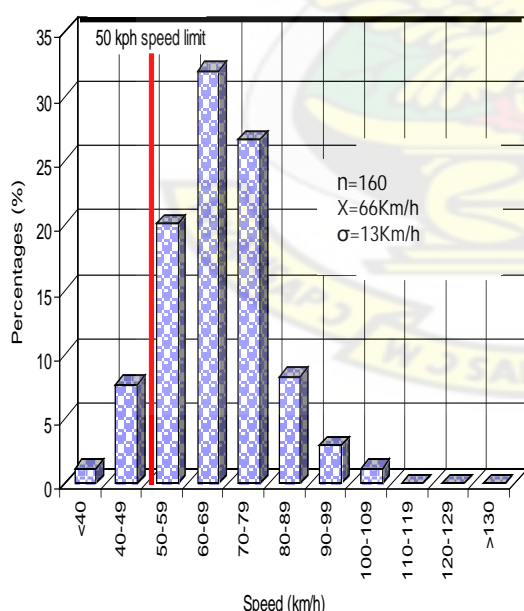
**Figure 4.3. Speeds at town gates**

The town gates with inscribed limits and the nearby rumble strips did not slow down vehicles considerably. The 50Km/h rumble strips at the outskirts town are almost flattened within the vehicle wheel-paths making it easy for vehicles to pass over without reducing speed. Figures 4.3, 4.4 and 4.5 show the speed distribution at Manhyia town.

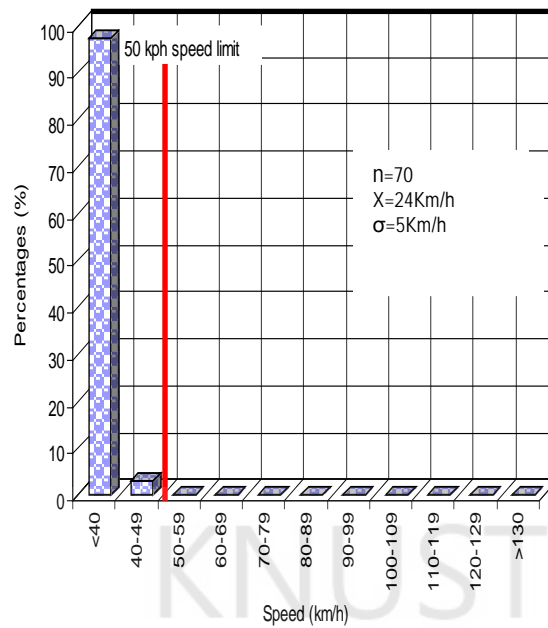
**Fig. 4.5. Speeds on speed tables**

Mean speeds measured on the speed tables and in-between speed tables are 24Km/h and 40Km/h respectively. The speed tables are about 85m apart.

In general, all categories of vehicles are compelled by the presence of the speed table to travel at speeds below the 50Km/h limit in the vicinity of the speed tables within the town.
