**ASSESSMENT OF REHABILITATED SURFACE MINE LANDS IN  
ANGLOGOLD ASHANTI, OBUASI**

A Thesis submitted to

**MASTER OF SCIENCE IN ENVIRONMENTAL RESOURCES MANAGEMENT**

AUGUST, 2013

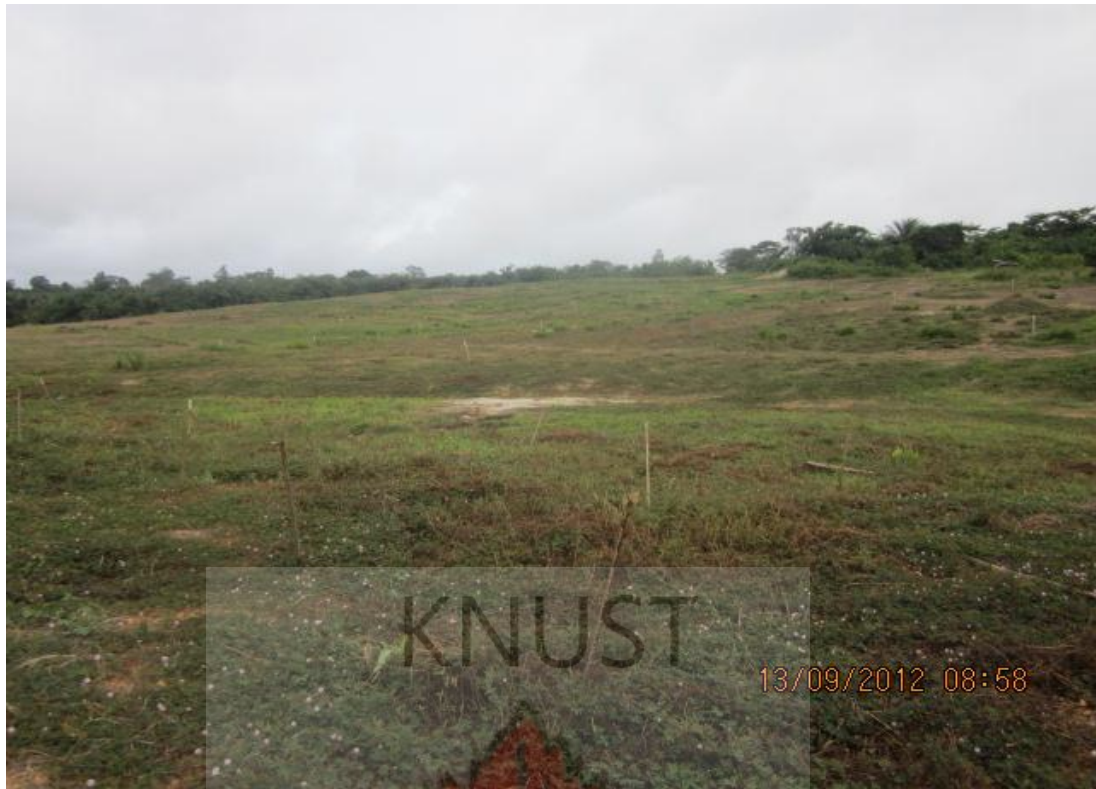
**Figure 3.3 One year old re-vegetated T3**

The T3 surface mine site as shown in Figure 3.3 is about a year old after rehabilitation. It is located along the Obuasi airport road at about 2.16 km from the Obuasi-Kumasi highway with a total re-vegetated area of 6.8 ha.

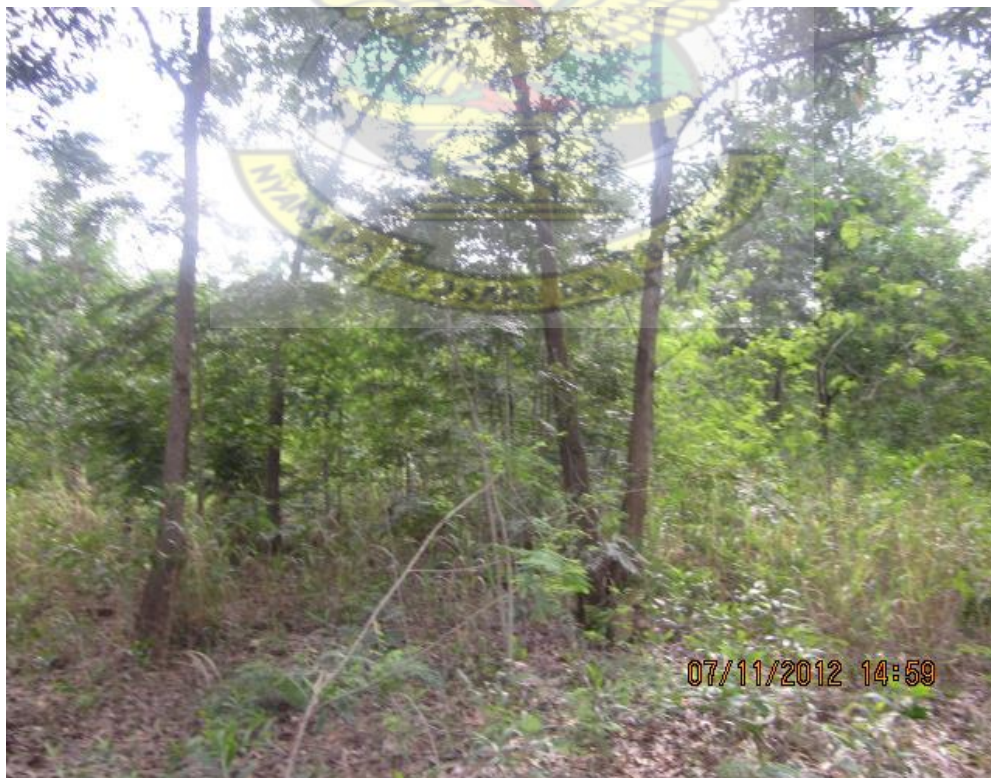
**Figure 3.5 Twenty year old rehabilitated Justice Site**

Justice as shown in figures 3.4 and 3.5 is a surface mine site located behind the Kwesi Mensah shaft one of the currently operational underground shafts about 1km from Anyinam Lodge with a total re-vegetated area of 23.94 ha as shown in Figure 3.5. The rehabilitation of Justice was done about 20yrs ago. Prior to surface mining the vegetation was similar to that of T3.

The landscape reconstruction of Justice was also carried out on contract. Trucks, excavators and a compactor were used during the back filling. Waste rock was used for the backfilling followed by the spreading of subsoil which was also pushed from the adjacent sites into the pit. The soil was compacted with a roller to make the landscape more stable. Top soil was transported to the site and spread on the entire landscape of Justice.
