THESIS REPORT

**TOPIC:- A STUDY OF SEDIMENTATION MANAGEMENT
SYSTEMS AT NEWMONT GHANA GOLD LIMITED**

**PROJECT REPORT SUBMITTED IN PARTIAL FULFILMENT OF
THE REQUIREMENT FOR THE M.Sc (ENG.) DEGREE IN
ENVIRONMENTAL RESOURCES MANAGEMENT**

JULY 2008

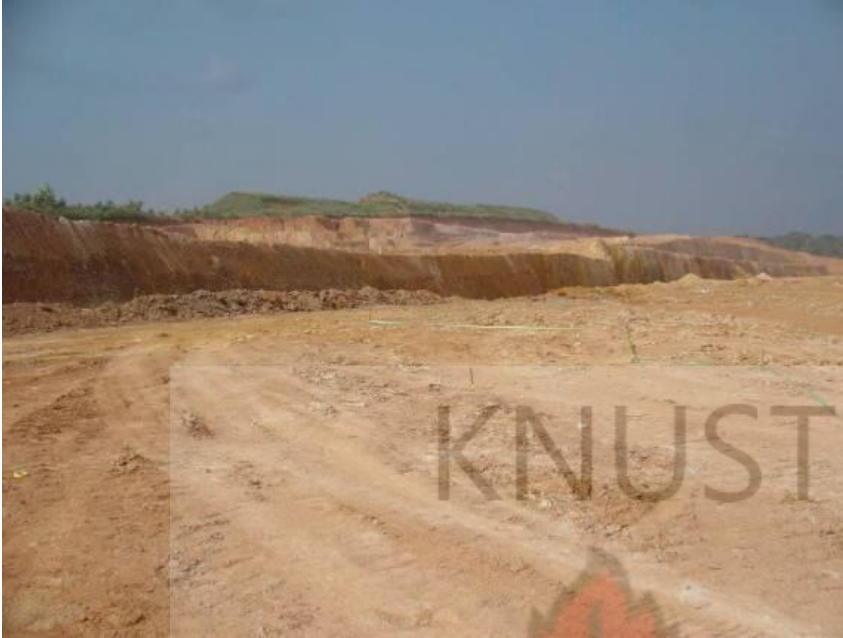
Figure 5. 10- Cleared and Excavated Portion of the Apensu Pit Area.

The development and operation of the mine in the study area has necessitated the clearance of large tracts of land. This activity has exposed large areas of land and has disturbed the general ecological balance of the site. Forested areas, open spaces, and other naturally vegetated areas have been permanently lost through clearing. At the mining sites large areas have been cleared for waste dumps and the excavation of mining pits and haulage tracts (Figure 5.10). These have resulted in the generation of large volumes of loose soils that can be easily carried by wind and rain as evidences on Figure 5.11.

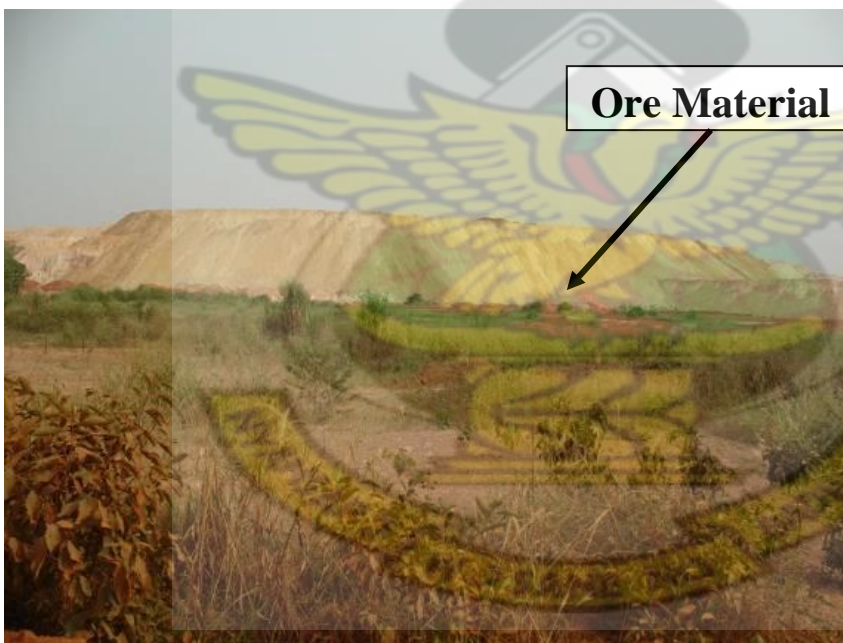
Figure 5. 11:- One of the Dump site of Excavations from the Apensu Pit

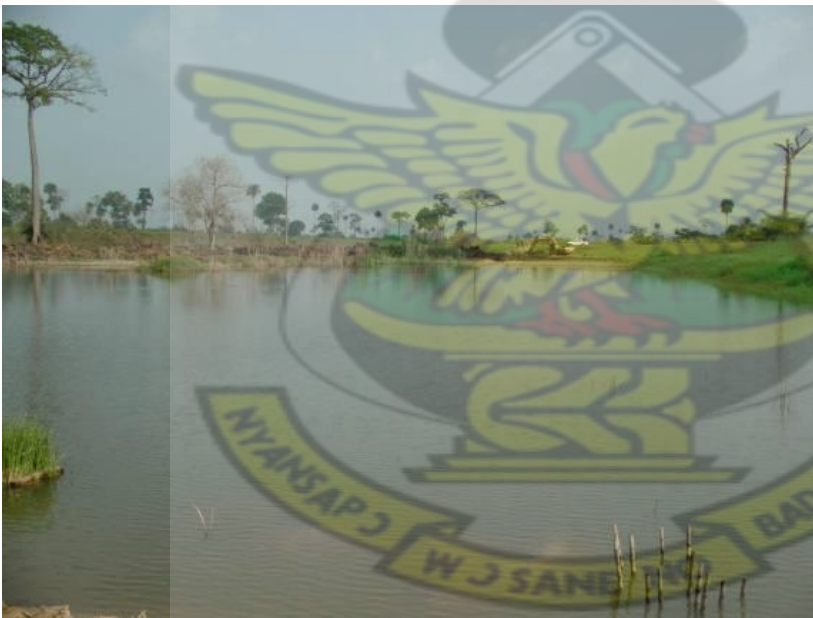
Figure 5. 12: Environmental Control Dams Six (ECD6)

The sedimentation dams as shown in Figure 5.12 are linked to channel/side drains which serve to direct the runoffs into the sedimentation basins.

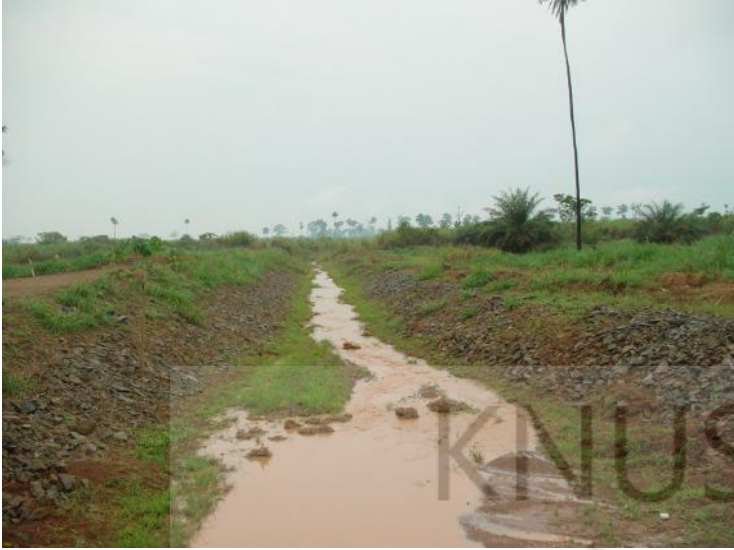
Figure 5. 13:- One of the Channels Created to Direct Runoffs from the Administration Area, Camp A and Plant Site to Sedimentation Basin ECD3

Of critically importance for the direction of run-off into the control dams are the side drains. There are net works of drainage channels constructed at various locations which ensure that various eroded material from the project area end up into the ECDs. In some locations these drains are lined with sorted rock materials derived from the mine pit and have rock cheek dams at intervals as shown on Figure 5.13. The essence of the rock lining is to reduce the erosion of the walls of the drains. In some locations these drains are planted with vertiver grass to filter the drain sediments.

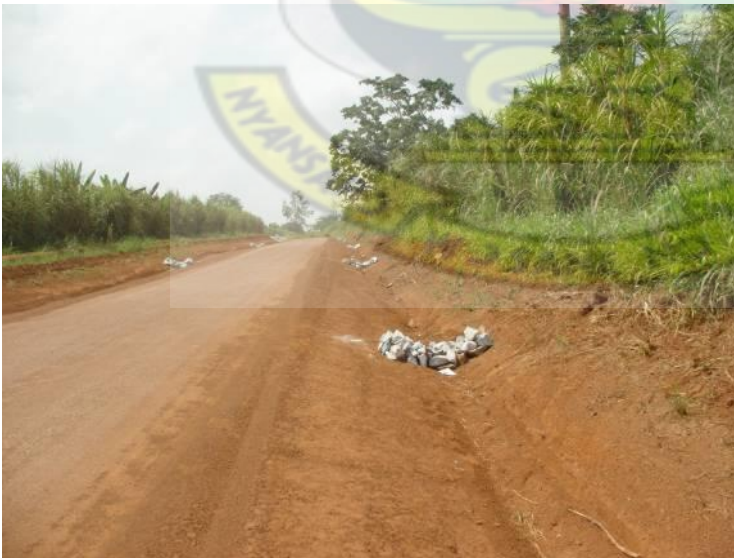
Figure 5. 14:- Newly Made Check Dams on Camp A – Ntoroso Road to Reduce Velocity of Runoffs and Aid Sedimentation.

Check dams as shown on Figure 5.14 are built to reduce water flow to non-erosive velocities and to allow relatively large-sized particles to settle out of the water and be deposited or trapped upstream of the check dam. In the ground-truthing of the area it was evident that check dams are one of the major sediment control practices in the study area. These check dams are made from fragmented rocks of granitoids derived from the Subika pit.

There was however a problem with the manner in which the system was being practiced. The first issue had to do with the arrangement of the check dams along the ditches. Normally check dams are used in series and should be located or spaced so that the toe of the upstream check dam is at the same elevation as the lowest point of the top of the downstream check dam. Therefore the steeper the slope the closer the check dams are expected to be. This does not seem to be the case in most of the sites visited. Secondly, it is expected that for the proper functioning of the check dams as sediment trappers when larger size fractions of stones are used smaller size fractions of stones are placed immediately upstream of the check dams to filter sediments. This is not the case for most of the check dams. Thirdly, in the cleaning of depositional sediments, collected sediments are not taken away from the sites but are only collected and deposited about two meters from their original position. The end result is that these materials are washed back into the channels immediately during rainfall. This practice therefore renders the check dams ineffective in respect of trapping fresh sediments that are being carried down from upstream.

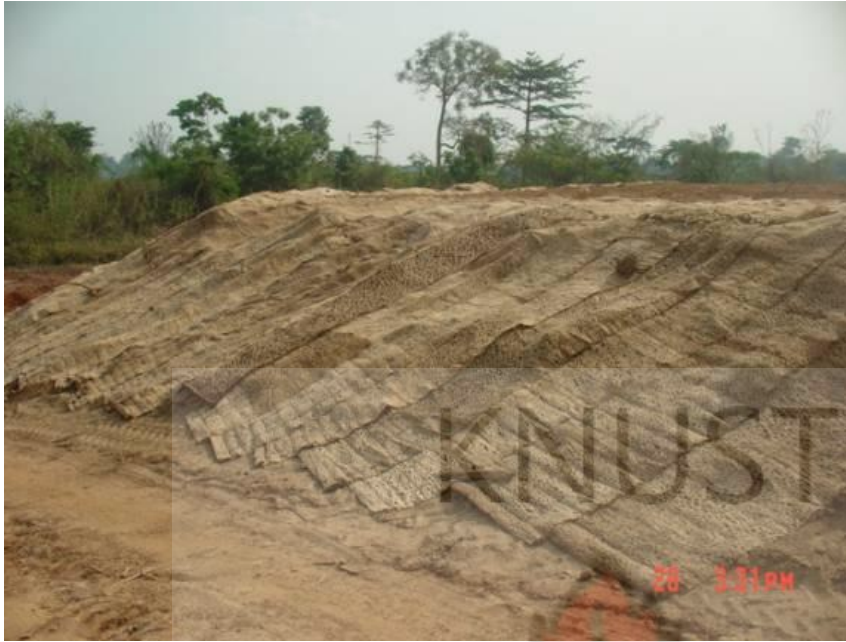
Figure 5. 15:- Covering Topsoil from the Subika Pit with Locally Made Jute Mat.

The jute mat serves to insulate the soil from erosive power of runoffs, insulates the soil from intense heat, and conserves moisture by limiting evaporation. By their nature they also enrich the soil as they decay. These blanket-covered grounds are then seeded and regularly watered by the use of a hydro seeder vehicle.

This study found these erosional control blankets as excellent materials for the steep slopes associated with the waste dumps and for areas that show concentrated flows. It was observed that the practice seriously reduced the erosive potential of runoff in such areas. The company has adopted the practice of planting grasses at areas which have been laid bare as a result of the constructional activities as evidenced by the activities shown on Figure 5.16. Grasses such as *Vertiva* are usually planted in such areas. The grass serves to reduce the impact of rain on the soil thereby reducing the potential of soil particles being carried away. It also serves as sediment traps preventing suspended particles from being carried away. The study found this to be very effective in checking erosion of sediments in the project area.

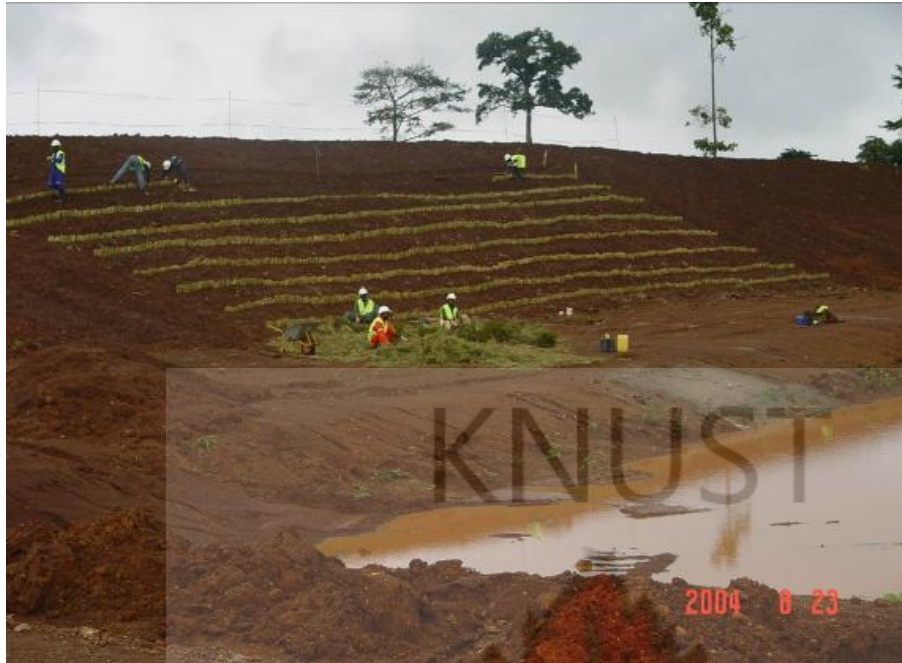
Figure 5. 16:- Newmont Workers Planting Grasses to Prevent Erosion Around a Sedimentation Dam
